**AN
INVESTIGATION OF INADVERTENT ARMING
OF
MK-82 AND M-117 GENERAL PURPOSE
AND
MK-82 SNAKEYE BOMBS**

TECHNICAL REPORT AFATL-TR-72-73

APRIL 1972

AIR FORCE ARMAMENT LABORATORY

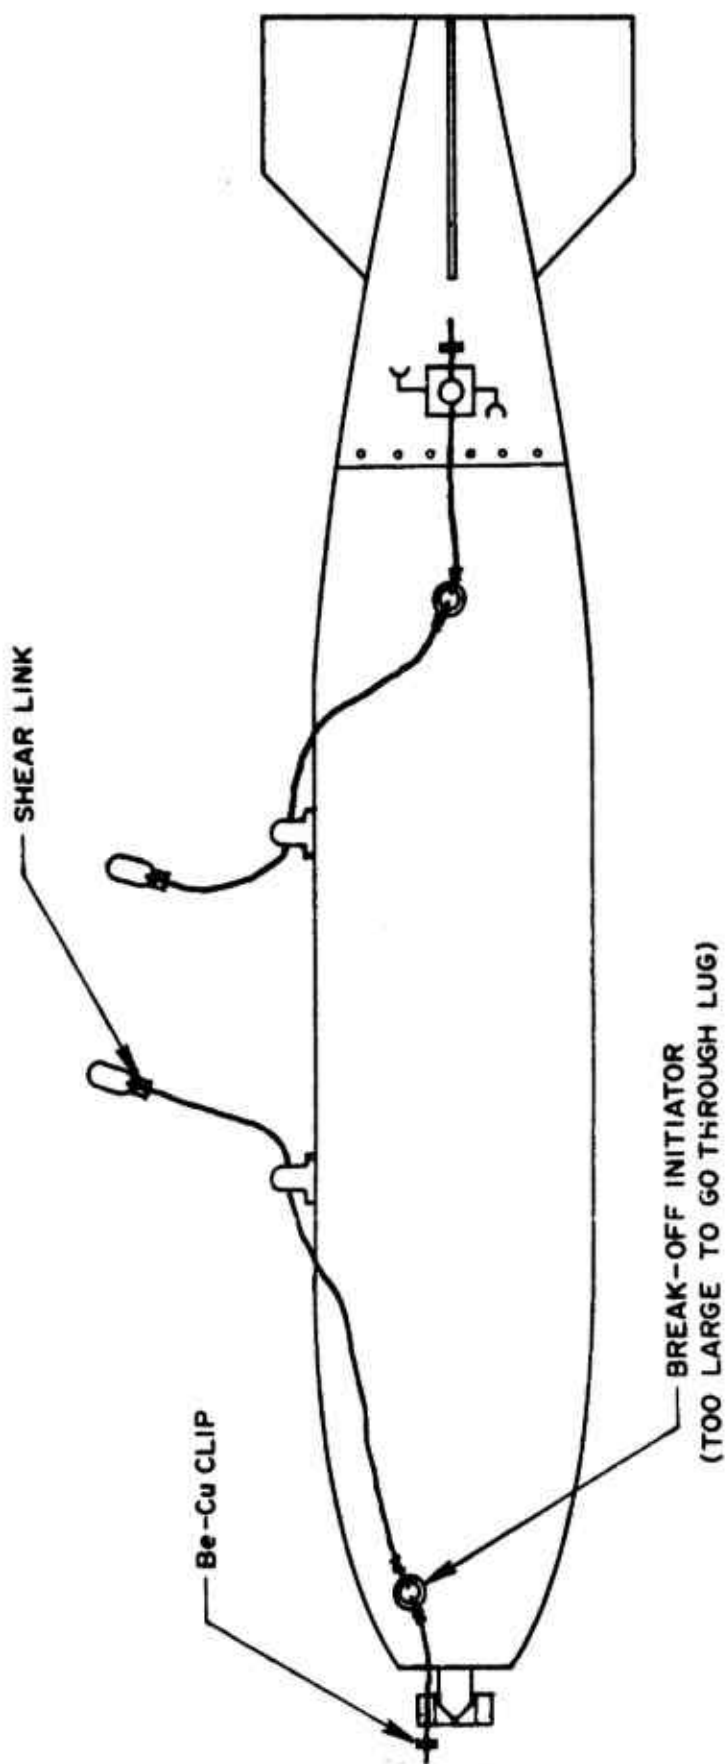
Figure 1. Direct Arming Wire Rigging

Because of the failures which occurred even with the most ideal conditions (small foot and wire on lower side), it was decided that the best solution to the inadvertent arming of GP bombs was direct routing. Direct routing consists of running the arming wire from the nose or tail fuze directly to the nearest solenoid. This solution would eliminate routing the arming wire past the ejector foot where it could hang up, and in addition, would provide a direct 1 to 1 relationship between the tensile force in the arming wire and the force on the solenoid. This relationship would make the force on the clip equivalent to the force on the solenoid so that a 14 pound force (if the solenoid could be assumed to operate reliably as specified) could pull the swivel and link from the solenoid before the clip is stripped from the wire.

The adverse effect of direct routing (the wires remaining on the aircraft) could be eliminated by incorporation of an AFLC/OOAMA proposal (Figure 1). This proposal includes adding a shear link and a break-away initiating component which would hang up on the lug, thus allowing the arming wire to fall away with the bomb.

To validate direct routing as a solution to the GP inadvertent arming problem, 12 bombs were released with the nose fuzing wire attached to the forward arming solenoid. Four bombs were released from the MER/TER center-line station and eight from the shoulder station, and all were successfully released safe as desired.

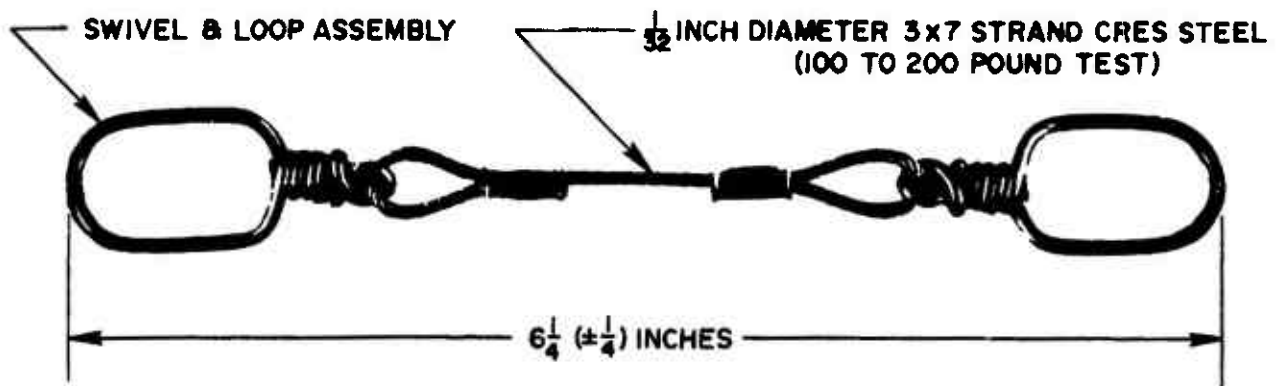
Figure 2. Pilot Option Lanyard

The initial results with one Be-Cu clip on the fuze wire were not favorable. A review of the film indicated that the wire was not hanging on the foot; however, the force on the wire was stripping the clip off the wire prior to extracting the swivel and link from the solenoid. In an attempt to alleviate this banjo effect, two Be-Cu clips were installed. Table IV indicates that the results were successful on the MER/TER centerline station but provided only partial relief of the problem on the shoulder stations.

The 7 and 38 percent inadvertent arming rates were unacceptable, and efforts were made to correct the problem. A pilot option lanyard was fabricated to allow the arming wire to remain taut against the bomb to prevent the wire from being pulled up over the foot by the swivel and link until the bomb had fallen away from the foot. The pilot option lanyard (Figure 2) consisted of two swivel and loops connected by 1/32 inch diameter steel wire cable to provide a total length of 6-1/4 inches. When the wire begins to be pulled by the swivel and loop, it is already beyond the ejector foot and therefore cannot hang on the foot.
